SUBJECT: Response Action Completion Report (RACR) for the Montana Road Rubble Dump Spill Site, SWMU 16, FTBL-028, EPA TX HSWA Permit I.D. # 4213720101, issued July 1991

1. Attached for your review and approval is the Response Action Completion Report (RACR) for the Montana Road Rubble Dump Spill Site, SWMU 16, FTBL-028.

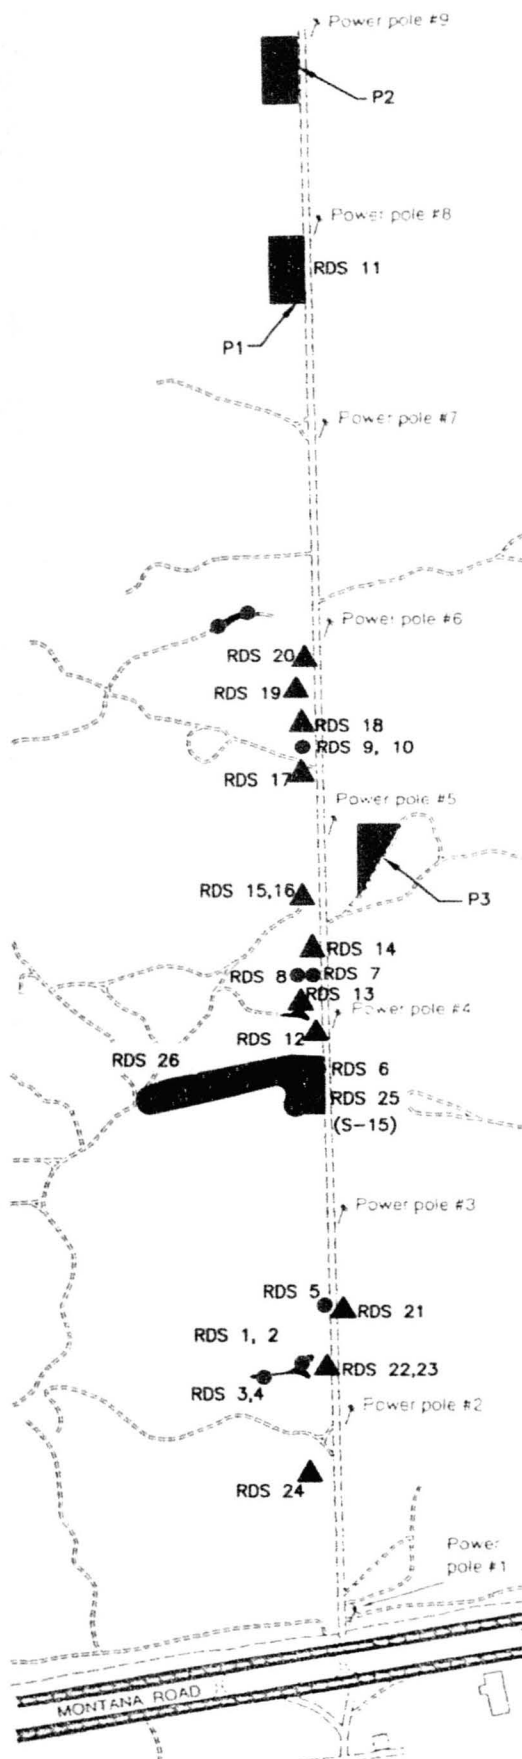
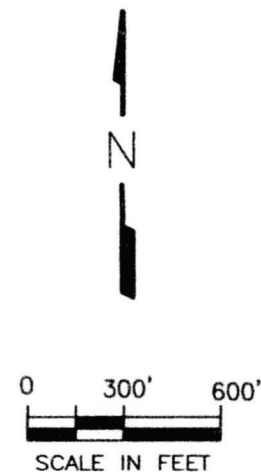
FIGURE 3
SAMPLE LOCATION
MAP
RUBBLE DUMP SPILL SITE
(SWMU 16)
FORT BLISS, TEXAS

NOTES:
1) RDS-SERIES SAMPLES COLLECTED DURING THE PRELIMINARY SITE INVESTIGATION (1995).

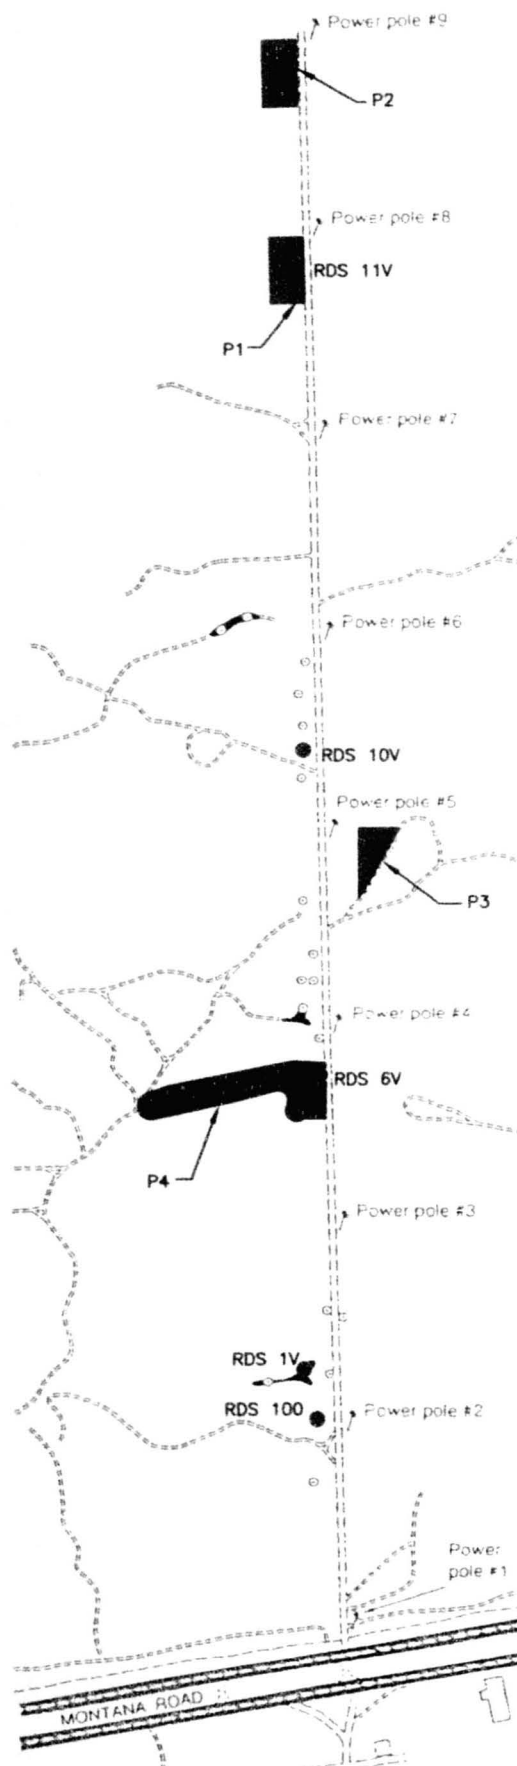
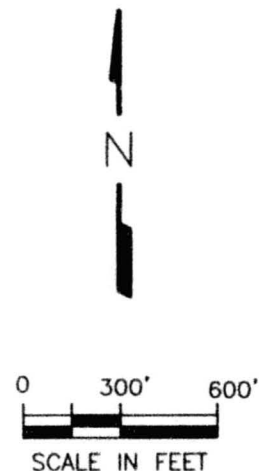
FIGURE 4
SURFACE SOIL EXCAVATION
AREAS AND VERIFICATION
SAMPLE LOCATIONS
MAP
RUBBLE DUMP SPILL SITE
(SWMU 16)
FORT BLISS, TEXAS

- 1) VERIFICATION SAMPLE FORT BLISS #1 WAS A COMPOSITE SOIL SAMPLE COLLECTED FROM EXCAVATED AREAS P1, P2, P3, P4 UPON COMPLETION OF THE EXCAVATION ACTIVITIES.
- 2) SURFACE SOIL SAMPLE RDS - IV, -6V, -10V, -11V, 100 WERE FINAL VERIFICATION SAMPLES COLLECTED ON NOVEMBER 6, 2000 AND JANUARY 3, 2001.

Four oil stained areas were identified during the Site Characterization, and these were referred to as Stations P1 through P4. Since the stations were relatively small, excavation of the visibly stained material was scheduled and completed. Approximately six (6) cubic yards of soil from the four areas (P-1 through P-4) were excavated and disposed off-site. A site map illustrating the areas of excavation is included as Figure 4. The excavated soils were stored in 55-gallon drums on-site pending laboratory analysis and waste characterization. Upon receipt of the sampling results, the drummed waste material was disposed at an approved facility as non-hazardous waste. Each excavation was then backfilled to surface grade with clean soil from the surrounding areas of the site.

After reviewing the available data on the site, Fort Bliss decided to collect additional verification samples to document that constituents of concern were not present at the site. In addition, Fort Bliss wanted to conduct additional site reconnaissance to document that additional waste disposal had not occurred at the site since completion of the removal activities. A site reconnaissance visit was conducted in November 2000, and evidence of additional waste disposal was not observed. Verification samples were then collected from four areas where elevated levels of TPH and SVOCs were reported in previously collected samples. These locations also corresponded to the areas scrapped and excavated during the response actions. The samples were labeled RSD-1V, RSD-6V, RSD-10V, and RSD-11V so as to correlate to previously established sample locations. The verification samples were collected from areas where small amounts of gray stained soils were located, and not in the excavation areas where backfill material was added. One additional sample was collected from an area near historical location RSD-24 where dark sandy was noticed during the November 2000 site reconnaissance. The samples were collected in November 2000 and January 2001, and the locations are shown on Figure 4.

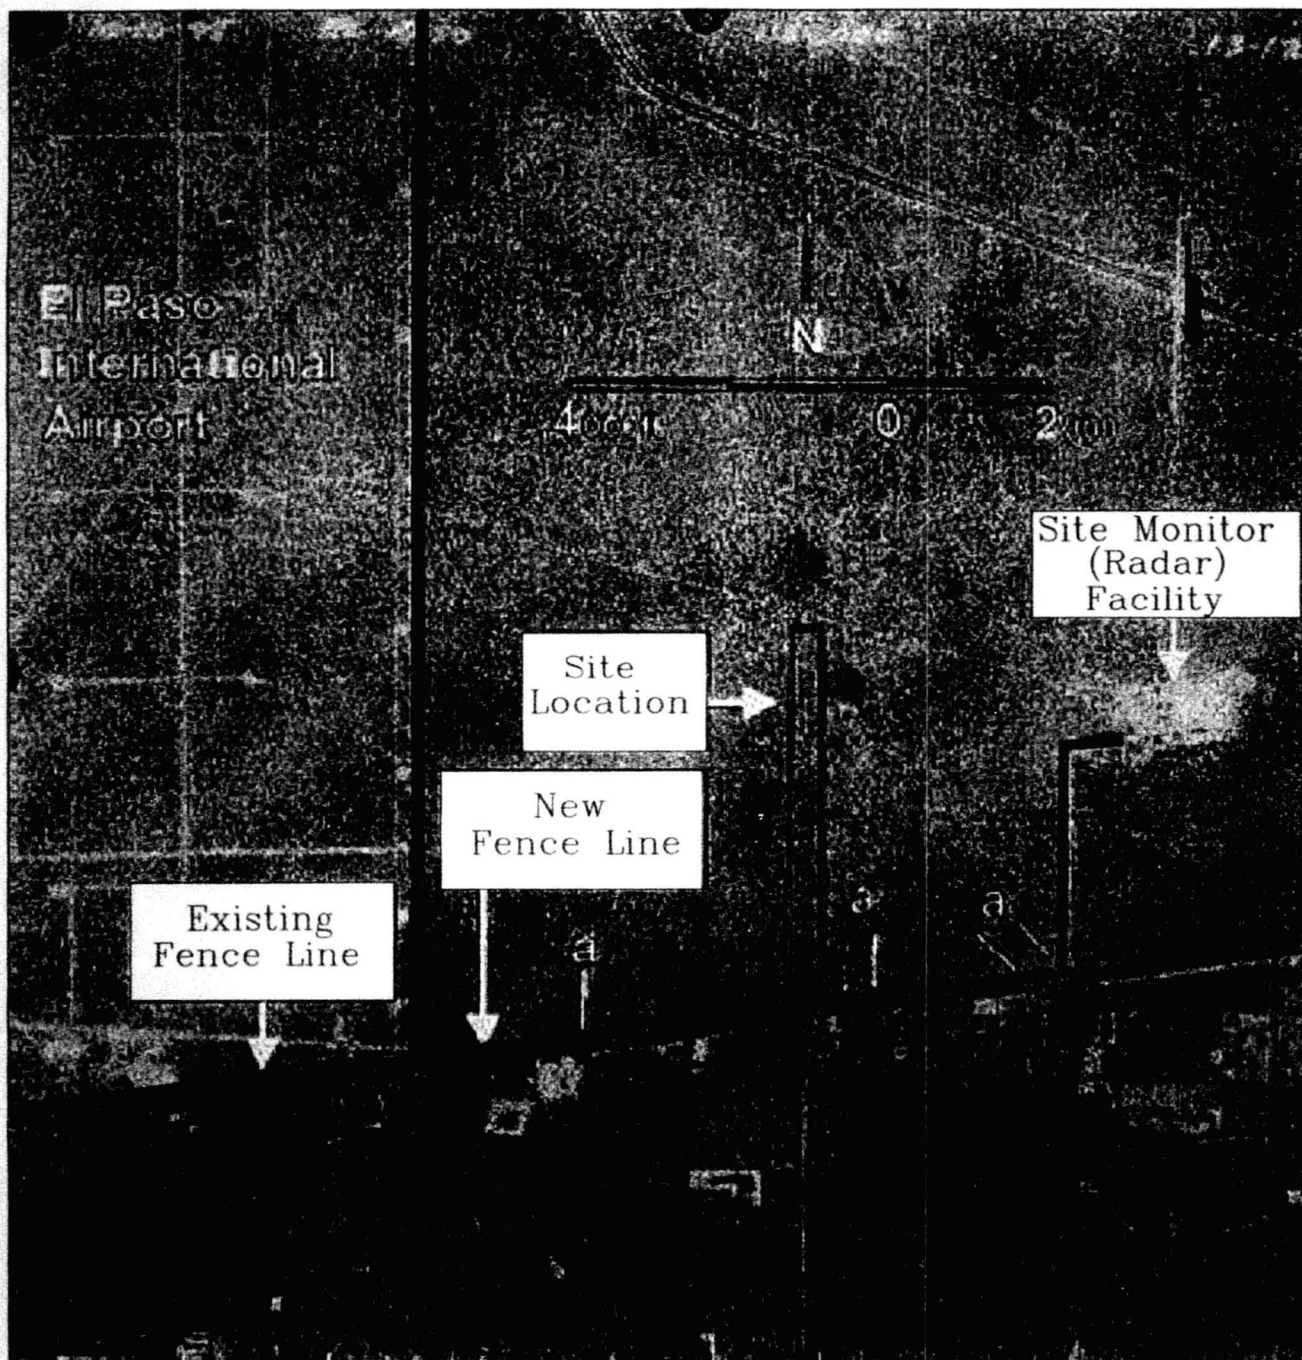
Aerial photograph of the project site and adjoining El Paso International airport property (Cooper Aerial Survey, 1995). Fence line for airport is illustrated in blue. The newly installed fence line for the rubble dump/spill site is outlined in green (a- Indicates typical site access points that were blocked by repairing the earthen berm.

Approximately a 1.7 miles stretch of the existing earthen berm along Montana Avenue and the Site Monitor access road was repaired. There were 11 commonly used access points that were identified that required repairs. These areas of the berm were repaired using a backhoe, medium-size bobcat, shovels and hand tools. The improvements to the earthen berm were conducted to reduce access to the site and surrounding areas. Photographs of the berm repair activities are described in Appendix C.

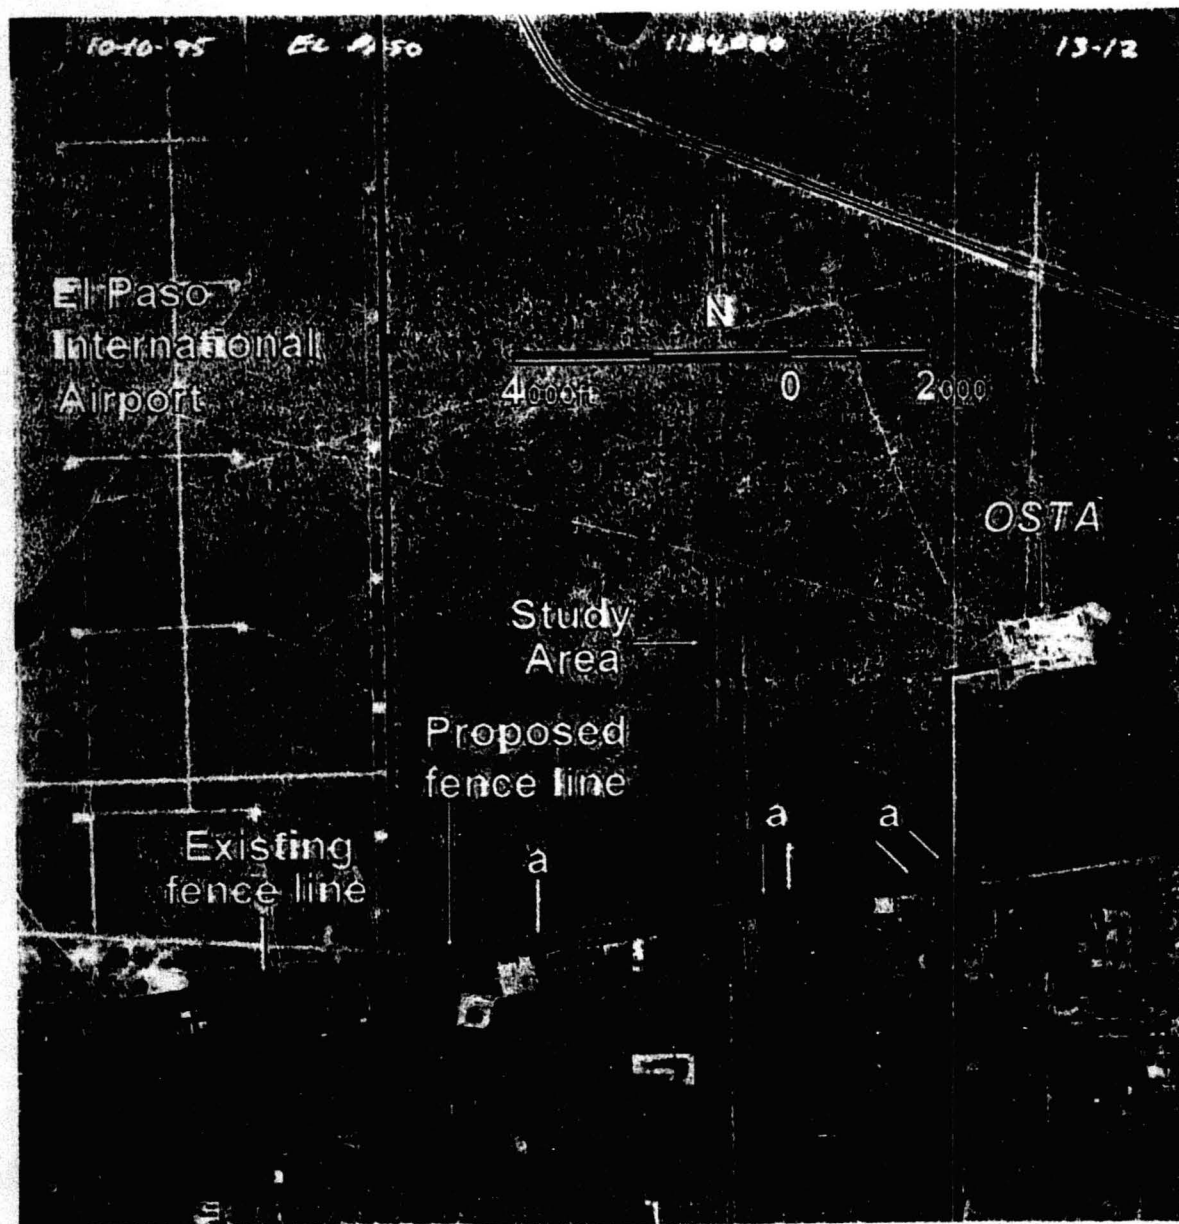
Figure 4. Aerial photograph of the study area and adjoining El Paso International Airport property (Cooper Aerial Survey, 1995). Fence line for airport is outlined in blue. Proposed fence line for the Rubble Dump/Spill Site is outlined in red (a - indicates site access points).

Another option to consider is the installation of a chain link fence. This fence would be 6 to 8 feet high and similar to the fence currently in place at the adjacent El Paso International Airport property. The cost of the chain link fence would likely be more than the barbed wire fence option but maintenance is likely to be lower. A possible disadvantage of this option is that medium-sized desert game may not be able to roam the site, a factor not likely to be a problem with a barbed wire fence. If chain link fence is selected as the engineering control method it is recommended that:

- The fence be placed in front of the existing dirt barricades;
- The fence be constructed from the corner of the El Paso International Airport fence line to the corner of the Montana Avenue and OSTA access road, then north to the OSTA employee parking lot;
- A zigzag pedestrian gate be installed so that walkers and recreational bicyclists can continue to use the area;
- Five to 10 individual barricades be constructed to stretch across the frontage road to further discourage access; and
- Visual inspections be performed on the site once a year for the first several years to evaluate effectiveness.

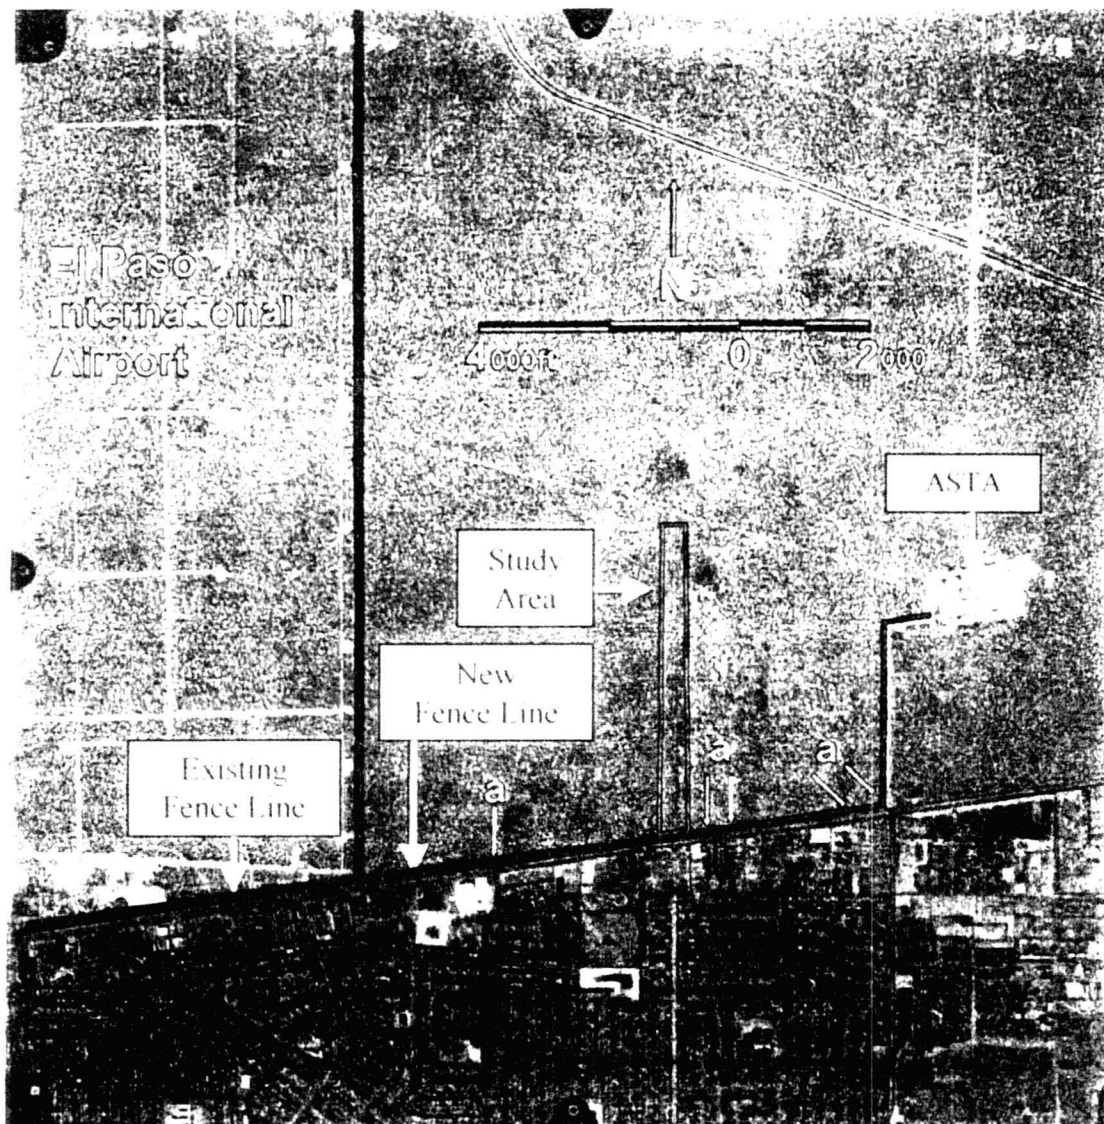
Attachment B Aerial photograph of the project site and adjoining El Paso International Airport property (Cooper Aerial Survey, 1995). Fence line for airport is illustrated in blue. The newly installed fence line for the Rubble Dump/Spill site is outlined in green (a-indicates typical site access points that were blocked by repairing the earthen berm). Recommended additional fence line is illustrated in red.

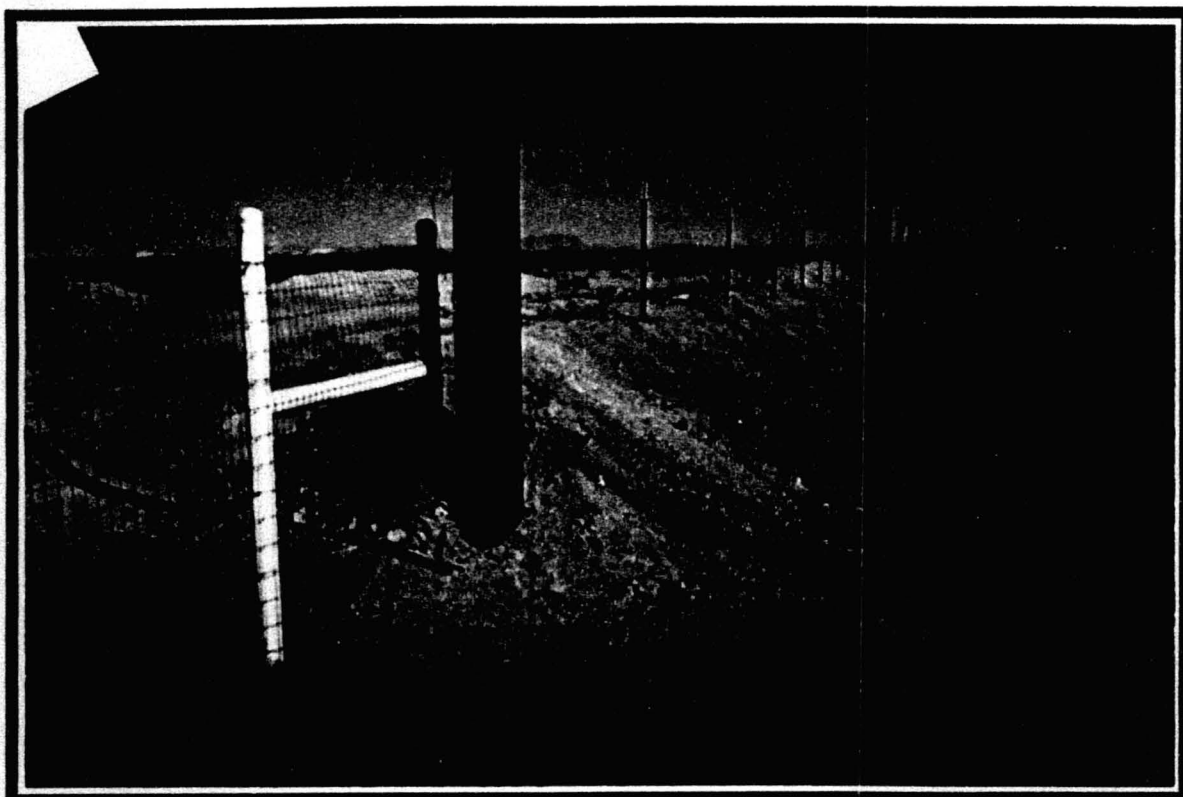
Photograph No. 3: The surveying was done to determine the east-west property line along Montana Avenue. Note the red-colored survey stake near the Montana right-of-way.

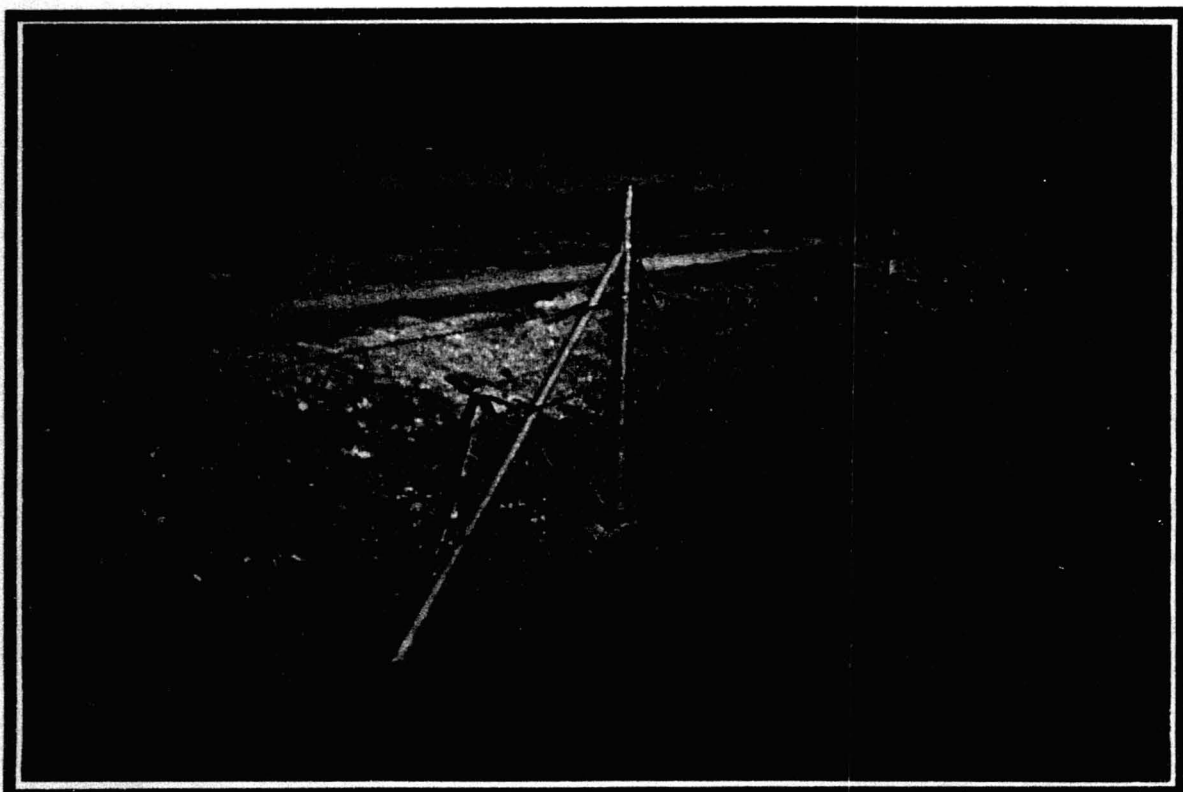
Photograph No. 4: The repaired earthen berm and the newly installed barbwire fence along Montana Avenue.

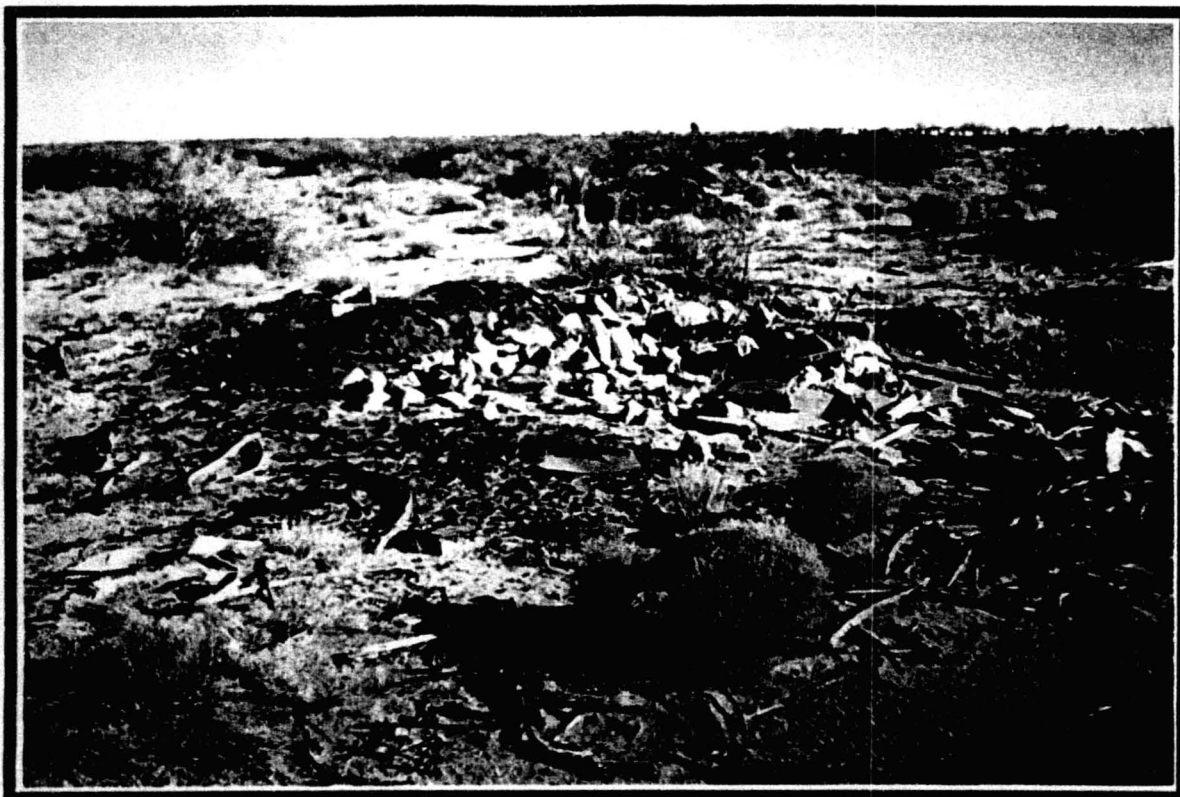
Photograph No. 5: Typical view of the subject site with concrete debris and roofing materials before clean-up actions were initiated.

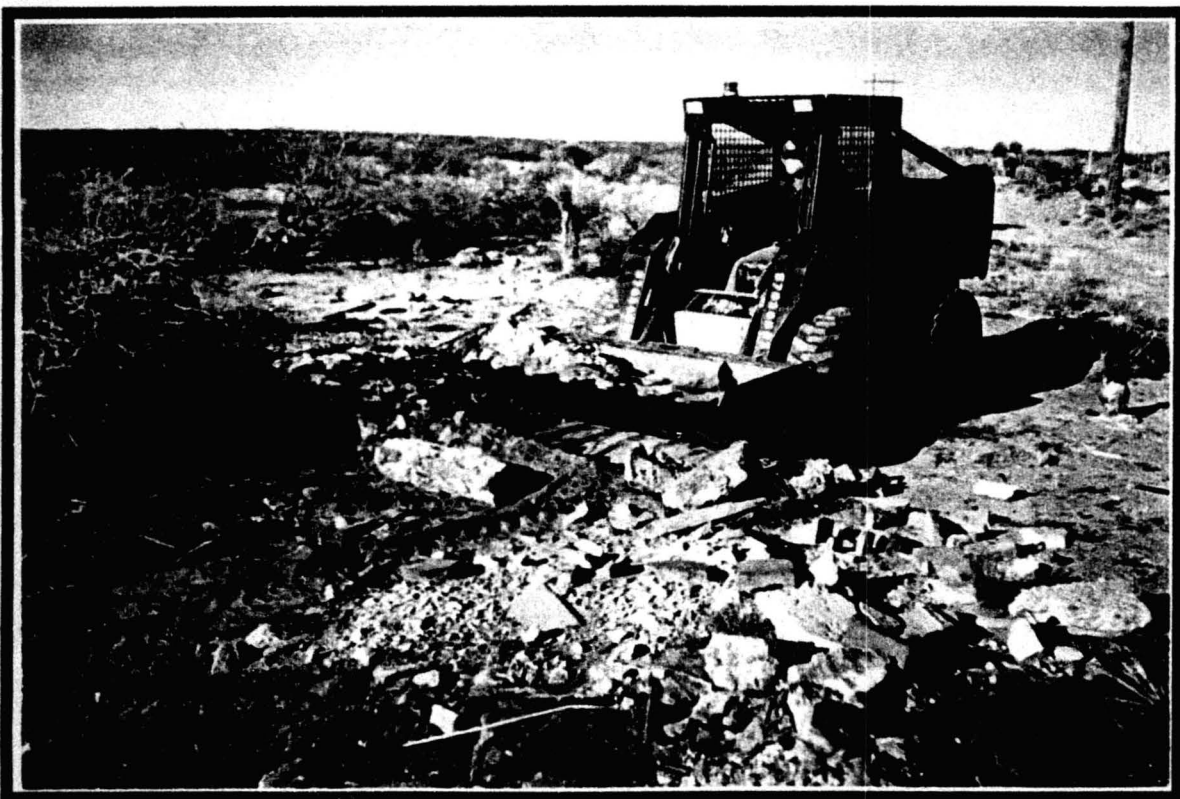
Photograph No. 6: General view of the field operations at the subject site where a medium-size bobcat was used to relocate the heavier debris to various collection areas.

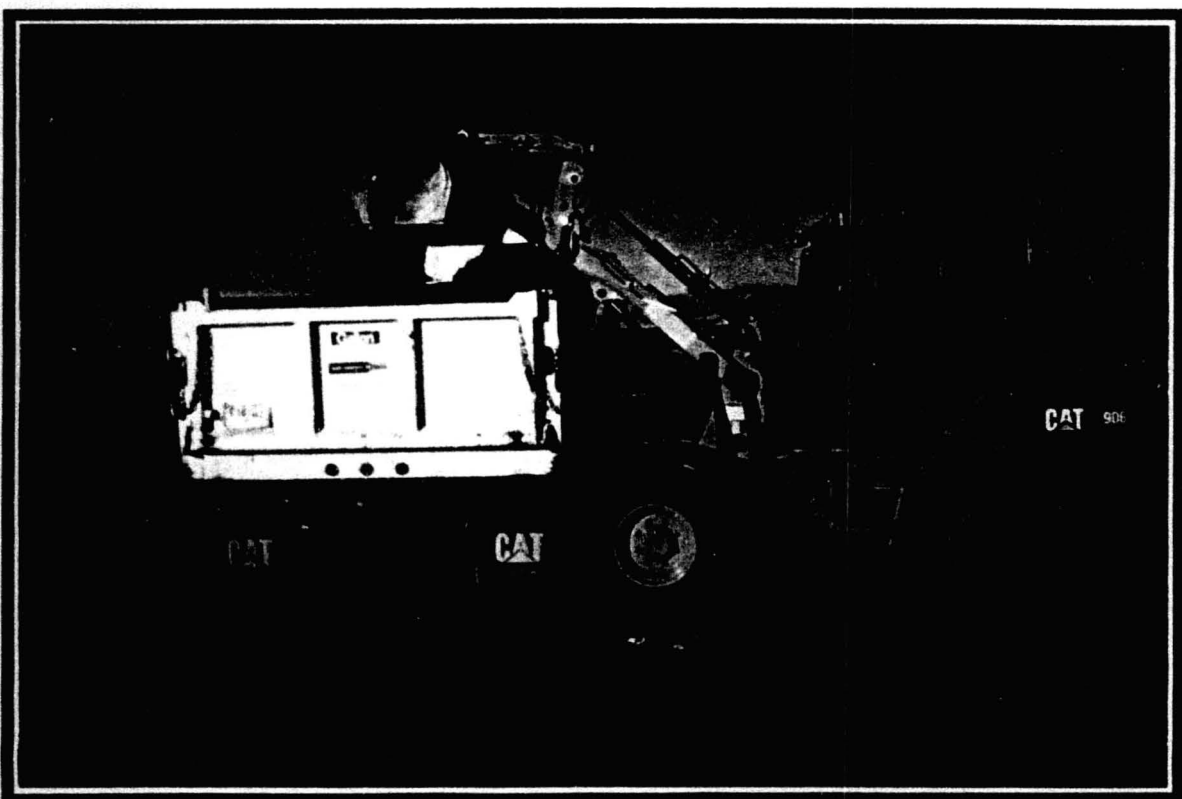
Photograph No. 8: A medium-size backhoe was used to load the dump trucks for disposal activities.

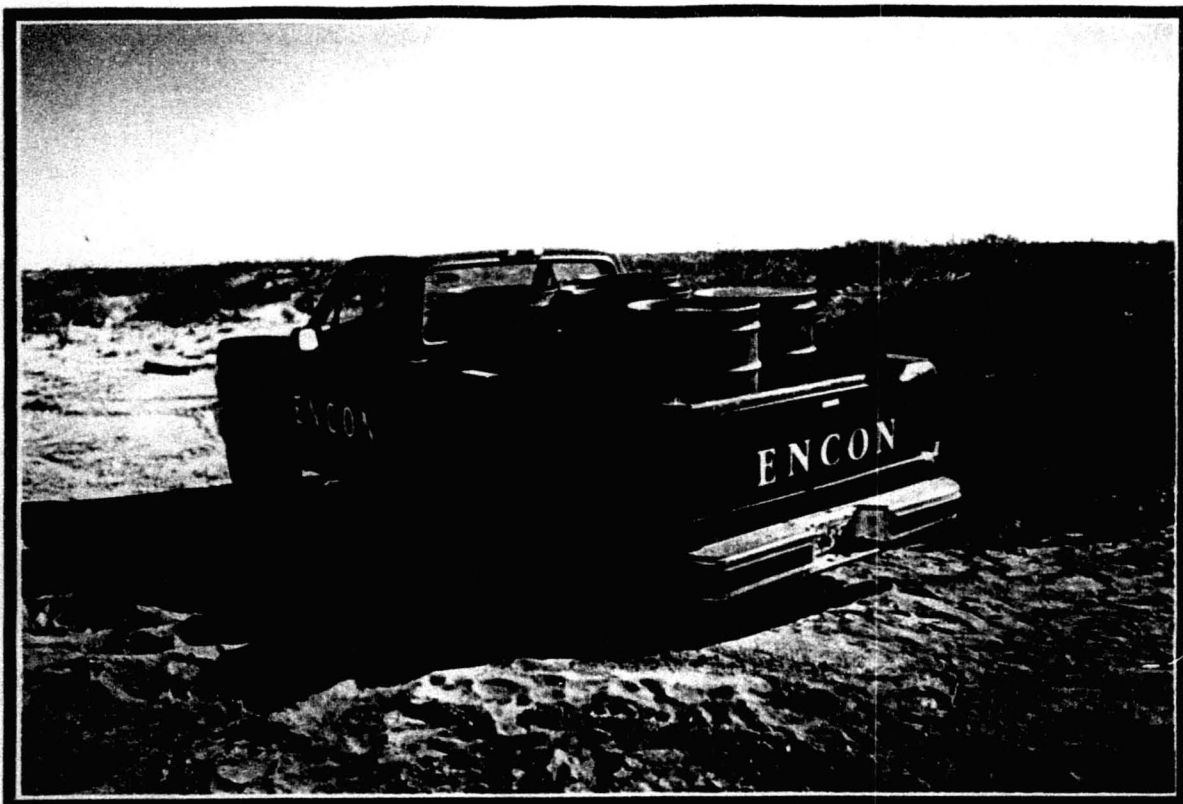
Photograph No. 9: View of disposal activities where hydrocarbon contaminated soil is being removed from the subject site.

The hydrocarbon impacted soil was placed into 55-gallon drums and stored onsite pending analytical results. Based on the analytical results for TPH, the soil was classified as a Class I, non-hazardous, regulated waste. On January 11, 2000, approximately six CY of the Class I, non-hazardous soil were transported to the Camino Real Landfill in New Mexico. Manifests for disposal of the soil is included are Appendix C.

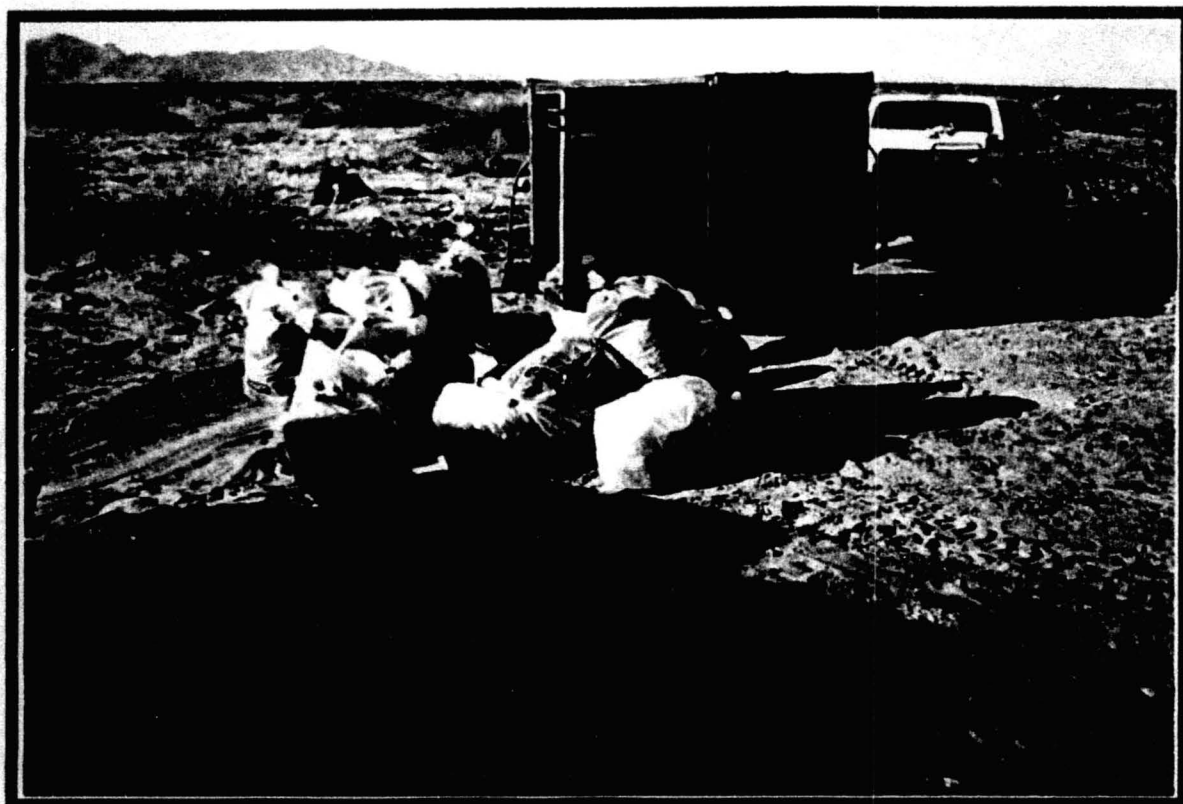
Photograph No. 10: View of the asbestos disposal activities at the subject site.

On 29 December 1999, approximately four yards of ACM were transported by Environmental Reconditioning to the Otero County Landfill in New Mexico. The TNRCC hazardous waste manifest is included in Appendix C.

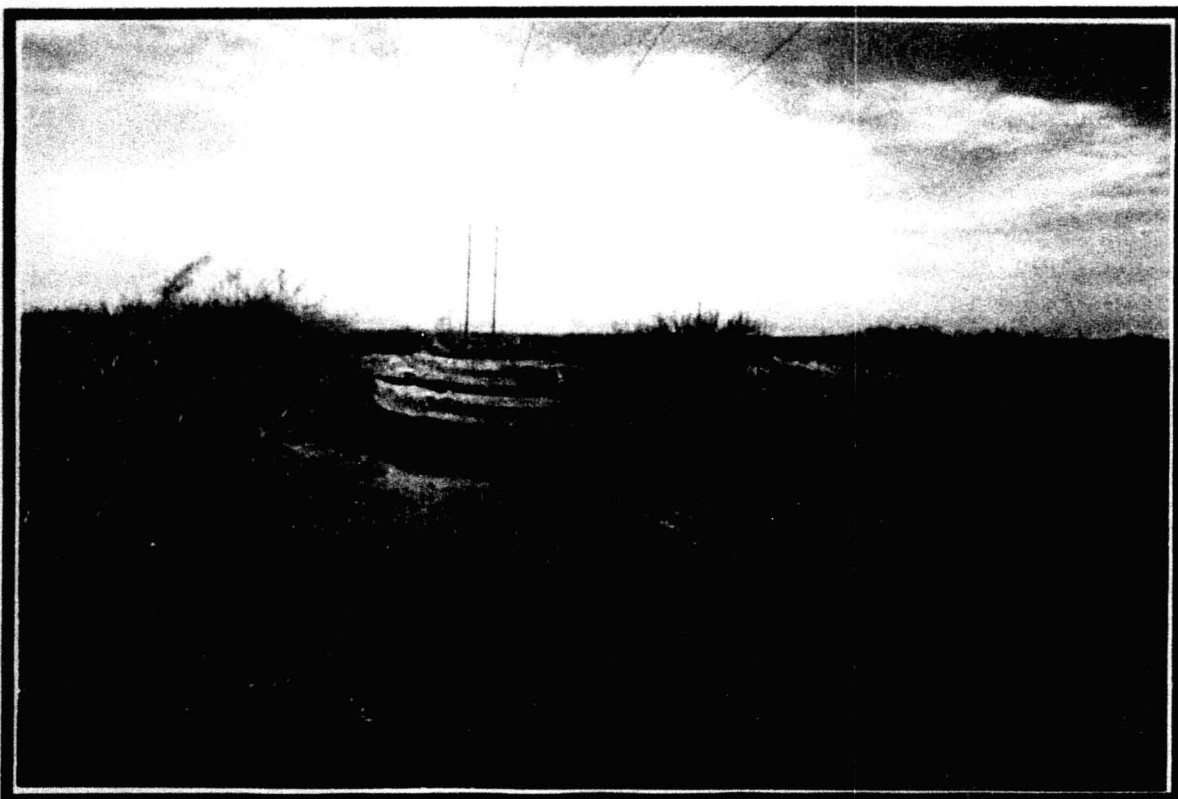
Photograph No. 12: General view of the remediated subject site near the main entrance.

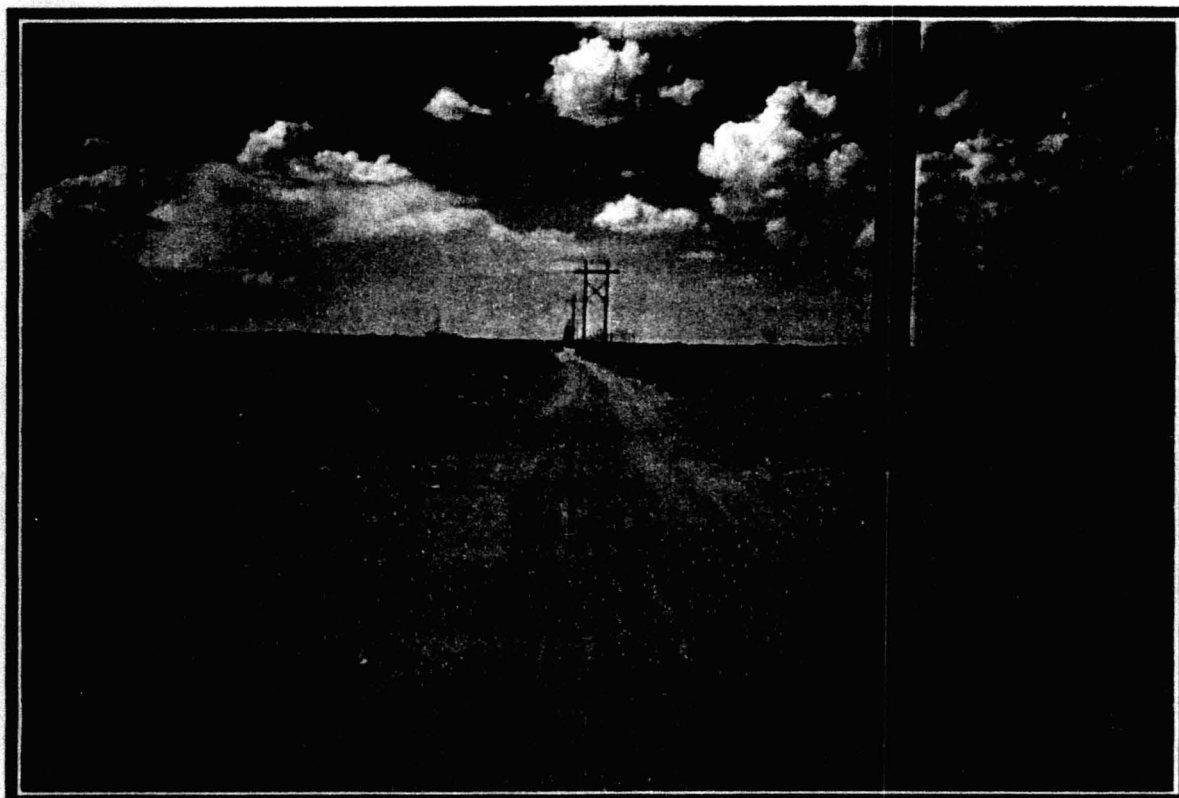
Photograph No. 14: View of remediated area between power poles 8 and 9, near northern portion of the north-south pathway (May 25, 2000).
